Inadvertently Programmed Bits in Samsung 128Mbit Flash Devices: A Flaky Investigation

Gary Swift

Jet Propulsion Laboratory / California Institute of Technology,
Pasadena, CA
gary.m.swift@jpl.nasa.gov

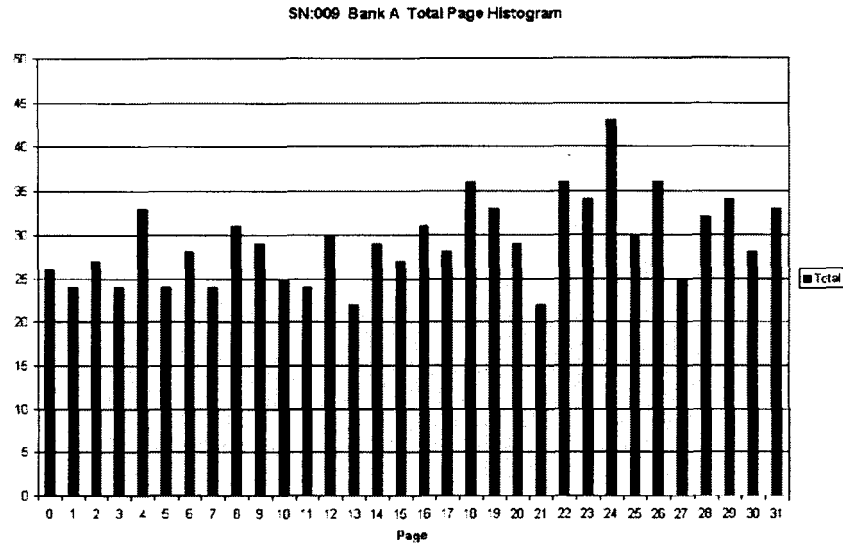
- 1) Colder is worse. Note that the cold temperature used was -55 degrees C, well below the part spec. limit.
- 2) Lower bias is worse.
- 3) Both the number of flaky bits and the likelihood a flaky is in error increase with cycling.
- 4) Pseudo-random patterns were worse than checkerboards.
- 5) Of the two lots used, the Side A lot was significantly worse (see Fig. 1A & B).

Two factors likely confuse the interpretation. First, as stated above, it is clear from Fig. 1 that the dominant physical mechanism causing bit errors is different in the two lots of devices used in the exploratory investigations. Second, none of these investigations make a distinction between factors affecting *damage accumulation* and those affecting the *observation of the damage*. It is likely that some parameters may affect the two in opposite directions, but the investigations only observe the *net* effect. For example, it seems likely that higher bias will cause more wearout, but the observation of more errors at lowered bias may be the result of shifting the sense amp's detection threshold. The observed temperature dependence could also be an example. The observation of more errors at lower temperature could be explained by either increased inadvertent charging or from shifting minimum detection level against a fixed distribution. (It could also be the result of tilting the competition between wearout and annealing towards the former).

Fig. 1a: Histogram of Bank A for serial number 9

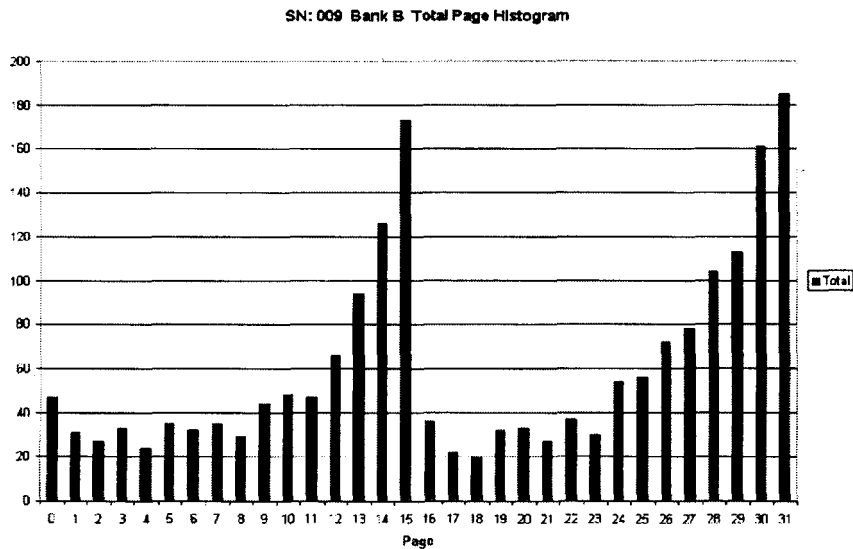
Fig. 1b: Histogram of Bank B for serial number 9.

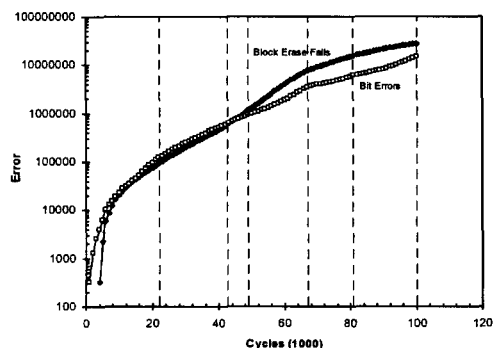
degradation). The experiment terminated when 100,010 cycles (one tenth of the part spec maximum) were reached. The experiment which required 833 hours of cycling time (about five weeks) was conducted over a four month period; during idle times, the devices were unbiased and ambient temperature. Figures 2a and 2b show the accumulation of bit errors and block-erase fails for Side A and B, respectively, over the entire experiment as a function of cycle.

Fig 2a: Dependency of errors on cycles for Side A

During full speed cycling, any words with errors as detected by the EDAC on read were counted. At six irregular points in the cycling, a slower set of cycles were run to record the particular block numbers with erase fails and also bit error locations and values. These characterization stops are indicated on Figure 2. Note that the number of blocks mapped out is sometimes increased at these spots, as indicated on Figure 2. Through cycle 49080, only a composite of the original manufacturer's bad block lists were mapped out – 13 on Side A and 20 on Side B. After that the number mapped out increased significantly going to 366 on Side A and 91 on

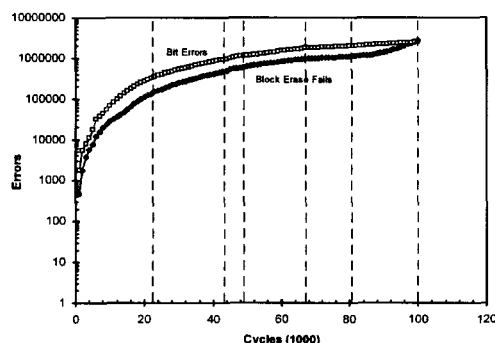
Fig. 2b: Dependency of errors on cycles for Side B

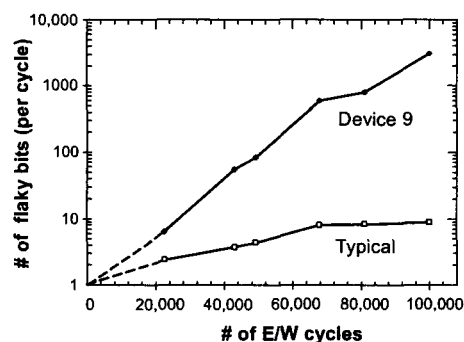
Finally, Figure 3 shows how the number of flaky bits increases with the number of E/W cycles. The number of errors was adjusted for visibility and pattern. Note the much larger error rate for the abnormal device (unit 9) compared to typical devices.

Fig. 3: Increase of flaky bits with E/W cycles for device 9 and a typical device
